Yellow Spur Rope Failure Investigation by **Rocky Mountain Rescue Group**

March 6, 2011

On the morning of June 22, 2010, Joseph Miller fell while leading the second pitch of the Yellow Spur¹ route on the Redgarden Wall in Eldorado Canyon State Park². During the fall the climber's rope failed, resulting in a fatal ground fall.

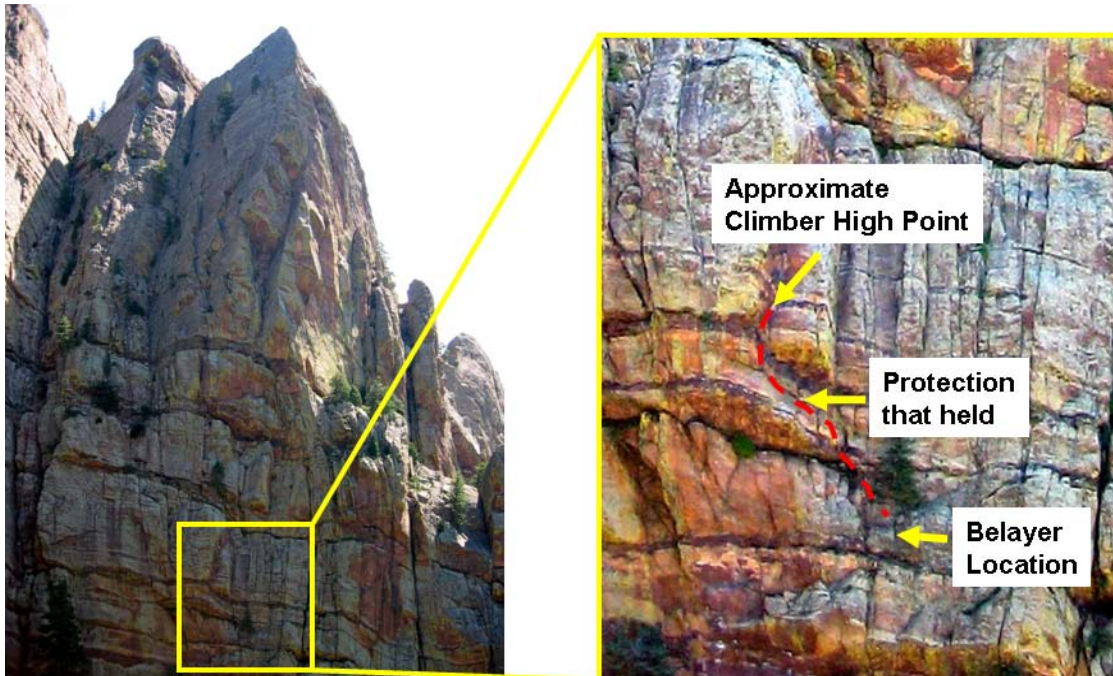
Figure 1a shows a photo of the Yellow Spur route with the area of the accident outlined in yellow. The second pitch of the route starts from a tree and traverses to climber's left before heading up a dihedral (Figure 1b). The route was closed temporarily following the accident in order to gather on-site information in support of the initial investigation conducted by the Boulder County Sheriff's Office (BCSO). Prior to re-opening the route, a detailed inspection of the second pitch of the route was performed by RMRG, and photographs were taken of the climbing protection placed by Miller during the climb.

Figure 1. a) Accident location on the 2nd pitch of Yellow Spur. b) 2nd Pitch of Yellow Spur labeled with approximate climbing route (dashed line), and approximate locations of the belayer, protection and lead climber prior to the fall.

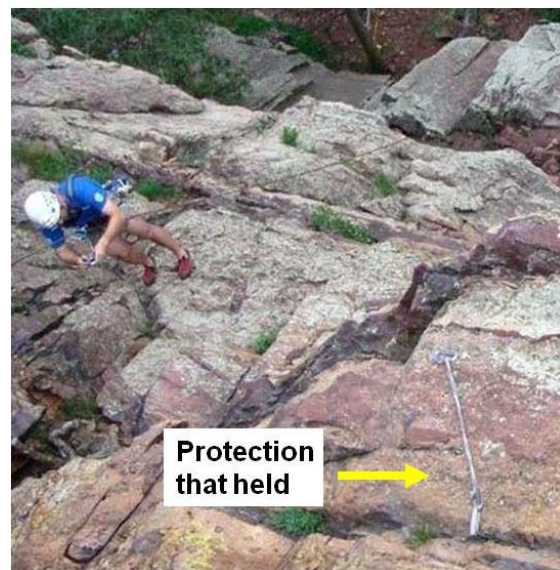
There are two additional important points from the belayer's account of the accident. First, he indicated that the initial protection placed by Miller had a long sling such that it did not cause the rope to change directions between the belayer and the second piece of protection. Second, the belayer indicated that he felt very little force on the belay from the fall. That is, he was not pulled significantly sideways or upwards by the rope as would typically be the case when catching a leader fall from this belay location. Immediately after the fall, the belayer pulled the remaining rope up to the belay and saw that the rope had been severed. He removed the first piece of protection placed by Miller before rappelling down to the base of the first pitch. The middle piece of protection (which held the fall prior to the rope failure) remained in place and was photographed during the initial investigation (Figure 2).

Figure 2. Protection that held during the fall (viewed from above).

The photo in Figure 2 shows the #0.4 Camalot and its associated sling and carabiners as they were found immediately after the accident. Prior to the fall, the climber's rope would have run up from the belayer, through the carabiner, and up to the climber's harness. As the climber fell past this point, the rope would have made a sharp bend through the carabiner and another sharp bend over the rock edge below the carabiner at the end of the sling. Another testing day was dedicated to measuring the resulting forces on a belayer under such circumstances. Figure 6a shows a close up of the geometry tested.

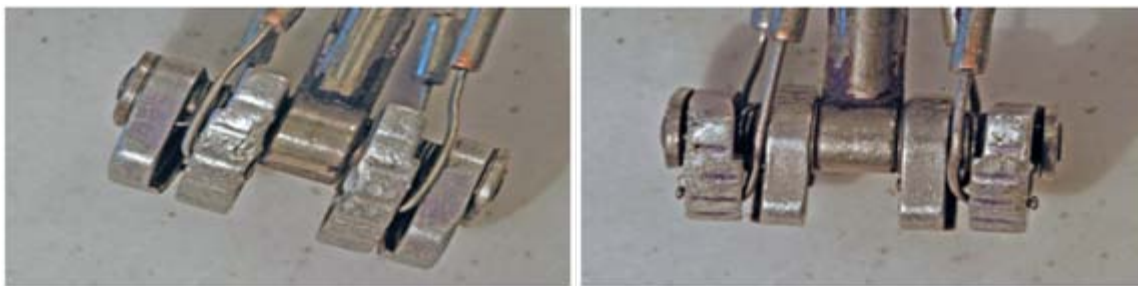
A detailed inspection of all climbing equipment found on the route was performed. In general, the equipment appeared to be in good condition. Inspection of the #0.5 Camalot found damage to the lobes consistent with a shallow or open placement and a force considerable enough to pull the device from its placement (Figure 3). Damage to its associated carabiners and sling were also consistent with damage caused by high impact with rock. The #0.4 Camalot and its associated carabiners and sling were found to be in good condition. The climber's rope was inspected over its full length. The rope failure occurred approximately 20 feet (6 meters) from a figure-8 knot that connected the rope to the climber's harness. There were light abrasions along the rope for several feet on the climber's side of the failure. In addition, there were dark discolorations on the belayer's side of the failure consistent with a loaded rope moving across a carabiner. The remaining ~175 feet (53 meters) of rope was in good condition. During this investigation, we found no reason to suspect that there was any rope defect or that this rope was particularly susceptible to the damage that occurred.

Figure 3. Close up of damage to cam that pulled out during fall.

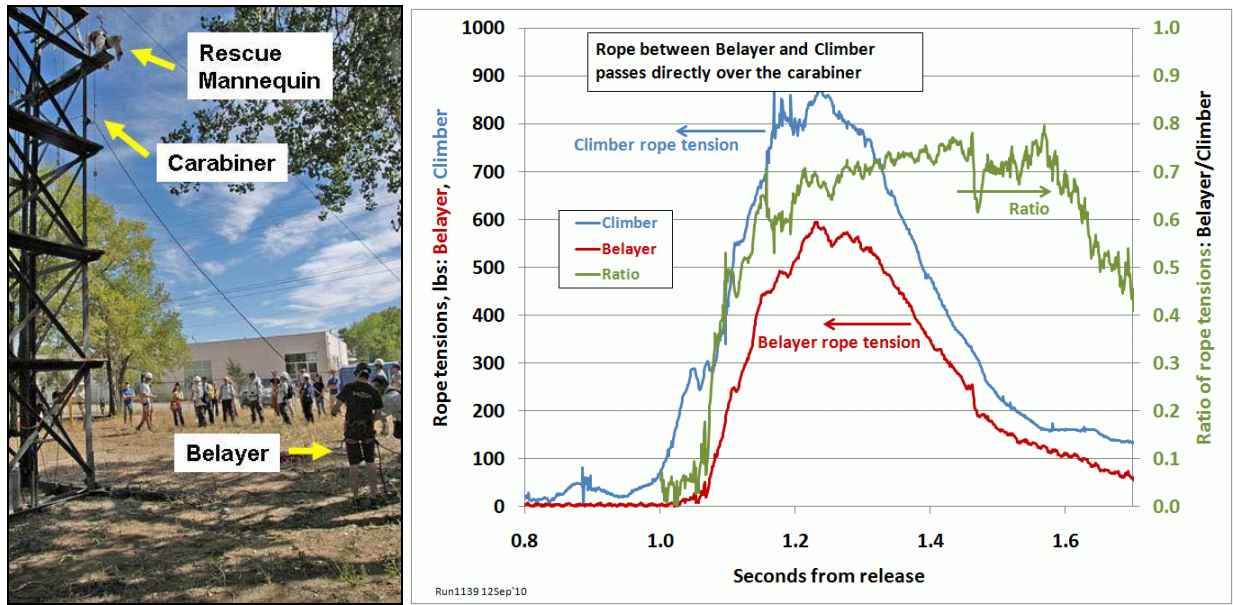
Figure 5. a) Climber and belayer forces drop test. b) Climber and belayer forces during leader fall.

Load sensors at the belayer and on the falling climber measured the resulting forces. Figure 5b shows the change in force (left vertical axis) and force ratio (right vertical axis) over time (horizontal axis). The force ratio is defined as the ratio between force experienced by the belayer to the force experienced by the climber. The force on the climber reached a peak of around 800 pounds-force (3.6 kN) at approximately 1.2 seconds. The force at the belayer was about 600 pounds-force (2.7 kN) at its peak. The ratio of the forces was approximately 0.7, consistent with the rope running cleanly through a carabiner.

The impact of 600 pounds-force (2.7 kN) lifted the belayer off the ground as the belay device caught the falling dummy during this test. Had a similar force been translated to the belayer during the Yellow Spur accident, he would have been yanked suddenly to the side (the second pitch starts with a traverse) as the rope came taught. Therefore, we can conclude that the belayer at Yellow Spur experienced a rope tension significantly less than 600 pounds-force (2.7 kN).

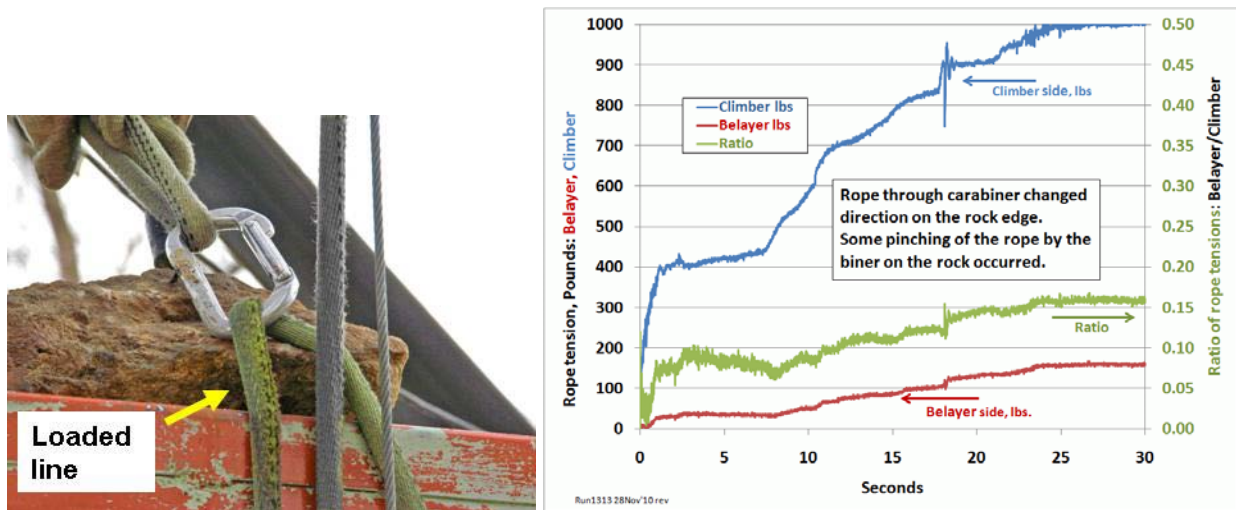
Figure 6. Rope changes direction over rock and through a carabiner: a) testing configuration & b) forces during a direction change.

Several variations of this general configuration were tested to determine whether and to what degree the carabiner could pinch the rope against the rock, and thereby contribute to a reduction of rope tension on the belayer's side of the carabiner. The results showed that the pinching effect may have contributed to the reduction caused by the rope bending over the rock edge. Figure 6b shows the forces measured in one such test as the weight is lowered onto the system. The graph includes the entire sequence from zero force on the climber's side to a peak of 1000 pounds-force (4.4 kN). During that time, the force on the belayer's side reaches a peak of approximately 150 pounds-force (0.7 kN) for a ratio of ~0.15. The reduction in force from climber to belayer in this configuration is quite large. When the climber's side of the rope is loaded to 800 pounds-force (3.6 kN), only 100 pounds-force (0.4 kN) occurred on the belayer's side.

These tests did not include manipulating the angle at which the rope bent over rock. However, the ratio of force reduction discussed above is exponentially sensitive to the angle of bend, such that an increase in the angle of bend would further reduce the belayer load. While it is difficult to determine the exact angle of bend that occurred during the Yellow Spur accident, the angle used in these tests was based on the photo in Figure 2 and is therefore similar to the angle that occurred during the actual accident. Therefore, these findings indicate that it is very possible for a belayer to feel little of the force of such a fall, given the geometry outlined above.

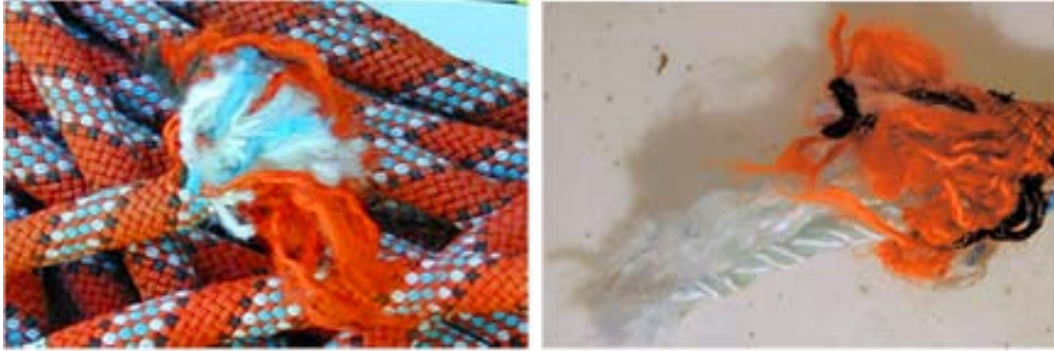
Figure 7 shows images of the climber's rope at both sides of the failure. The damage occurred over approximately two inches of rope. A short length of the rope's core strands were pulled out of the sheath at the point of failure during the accident.

Figure 7. Climber's rope at either side of the failure.

The damage characteristics of the accident rope (Figure 7) are consistent with the rock-cut test depicted in Figure 8b. These findings indicate that during the accident, the rope ran over a sharp object and failed at or near the highest point of tension.

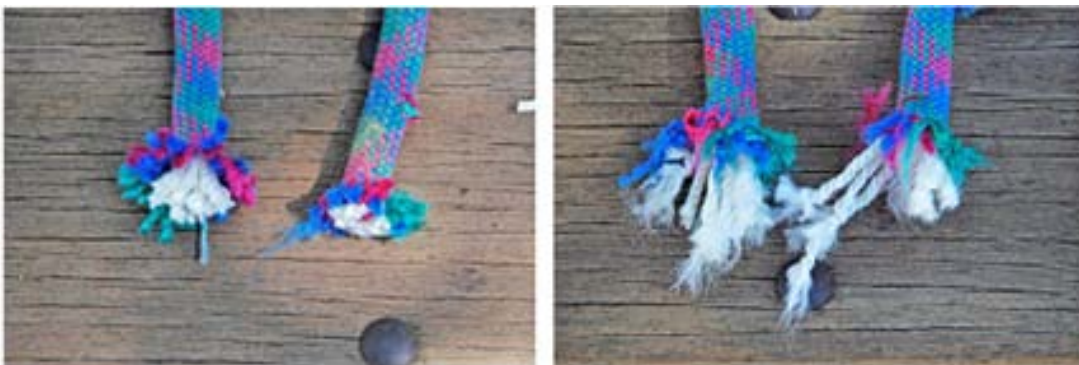
The testing done as part of this investigation included cutting similar ropes under various conditions in order to determine the possible mechanism of failure. These tests show that ropes cut under different conditions display distinctive damage characteristics. Figure 8 shows two cuts performed under different test conditions. In each case, the rope was loaded to 800 pounds-force (3.6 kN), and the rope was cut with a sharp object. The image on the left shows the type of damage that results when a sharp knife is lightly pressed against a loaded rope. The damage occurred very quickly, and the strands showed very little elongation. The image on the right shows the type of damage that occurs when a sharp rock is used to saw across a loaded rope. The resulting damage was more uneven. Core strands near the sharp edge broke at approximately the same time as the sheath while core strands further away stretched and survived slightly longer.

Figure 8. a) Tensioned rope cut with a sharp knife. b) Tensioned rope cut with a sharp rock.

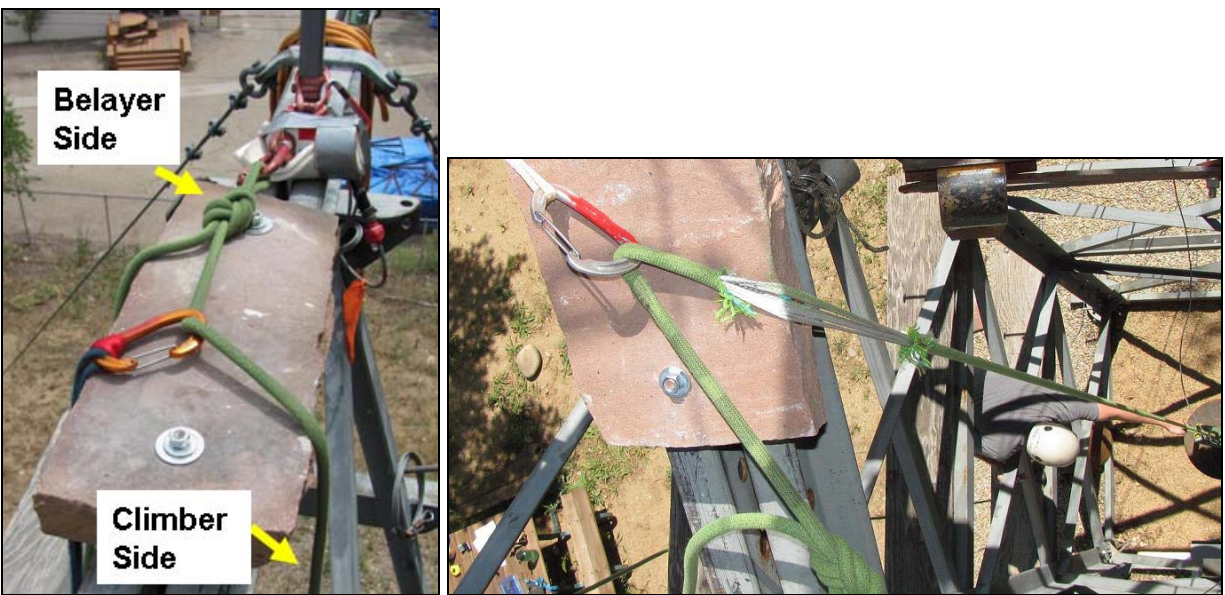
Figure 9. a) Example pre-drop configuration. b) Typical partial rope failure result.

Numerous drop tests were executed with several variations of carabiner-to-edge locations, types of rock edges, and fall line angles, such that the rope slid 1 to 3 inches along the sharp edge during the simulated fall. Each test resulted in significant damage to the rope. However, in several cases, the rope did not sever completely. Figure 9b shows the rope damage after a drop where the sheath failed but the majority of core strands survived.

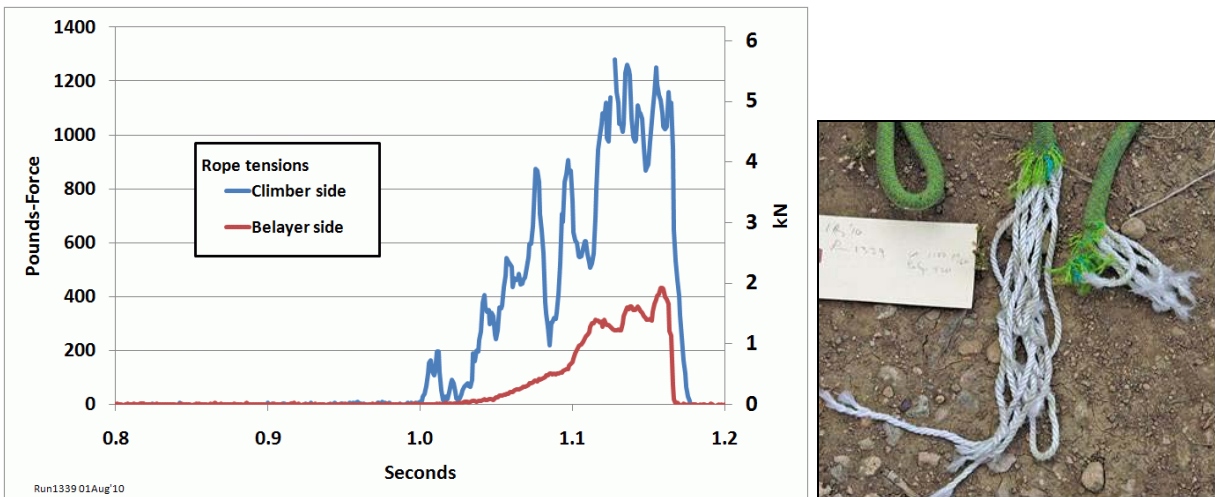
Figure 10a is representative of each of the tests in which complete failure occurred. The variability in the blue trace indicates the changes in force over time as the rope 'caught' temporarily on the rock edge due to friction and then released. The force drops suddenly to zero shortly after reaching its peak value, indicating the point of complete failure. The maximum load reached in this case was just over 1,200 pounds-force (5.3 kN) on the climber's side.

Figure 10. a) Typical loading during rope failure test. b) Typical damage caused during rope directly over sharp edge scenarios.

Figure 10b shows the type of damage done during each of the tests in which the rope failed completely. The sheath failed quickly and exposed the core strands to the edge. However, the core strands did not all fail at the same point. It is likely that as the rope is tensioned, it flattens across the edge, thereby protecting core strands that are further away, at least for a brief period of time. In addition, as the rope stretches, some of its length will become exposed to the edge and therefore the damage is spread across several inches.

While many of these tests were successful in creating complete rope failures, the characteristics of the damage were inconsistent with that of the accident rope (Figure 7). The damage to the accident rope occurs over a very short length, as if the contact point with the sharp edge did not change as the damage occurred. Therefore, it is unlikely that the accident rope failed due to the mechanisms or configurations demonstrated in this portion of the testing.

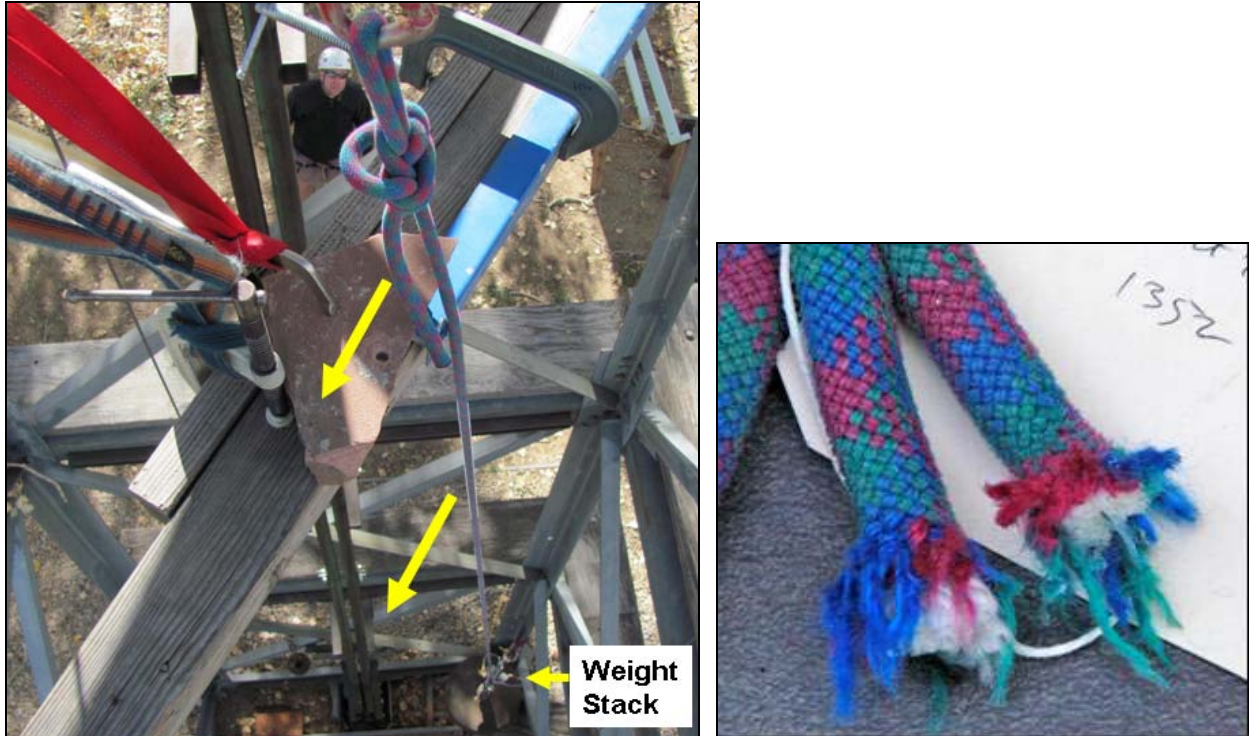
Figure 11. a) Test tower pendulum configuration. b) Pendulum test rope damage.

Different loads were used to simulate the downward force of a pendulum fall. Contact with the sharp edge of the rock during the pendulum resulted in considerable damage to the rope in each test. Using a load of 300 pounds-force (1.3 kN) caused the rope to fail, but only after sliding back and forth along the edge a number of times. However, there was no indication from witnesses to the accident that any such back and forth motion occurred prior to the rope failing. The remaining pendulum failure tests used a load of 760 pounds-force (3.4 kN). In each of these cases, the rope failed with only a single pass along the edge of the rock. Slow motion review of the video captured during the test showed that the rope passed over approximately 2 inches of the edge before failing.

Figure 11b shows the damage to the rope caused by the pendulum test with a load of 760 pounds-force (3.4 kN). The damage is isolated to a very short section of rope such that the sheath and core are cut at approximately the same location. The results of this test created a slightly cleaner cut to the rope than either the accident rope (Figure 7) or the test of the loaded rope cut by sawing a sharp rock across it (Figure 8b). In each of those cases, more of the core was

exposed. Thus, it is possible that some amount of stretch occurred as the damage was occurring during the Yellow Spur accident. It is also possible that variations in the sharpness of the different rock edges could account for the different damage characteristics. However, it seems clear that this type of failure mechanism was likely responsible for the rope failure during the Yellow Spur accident.

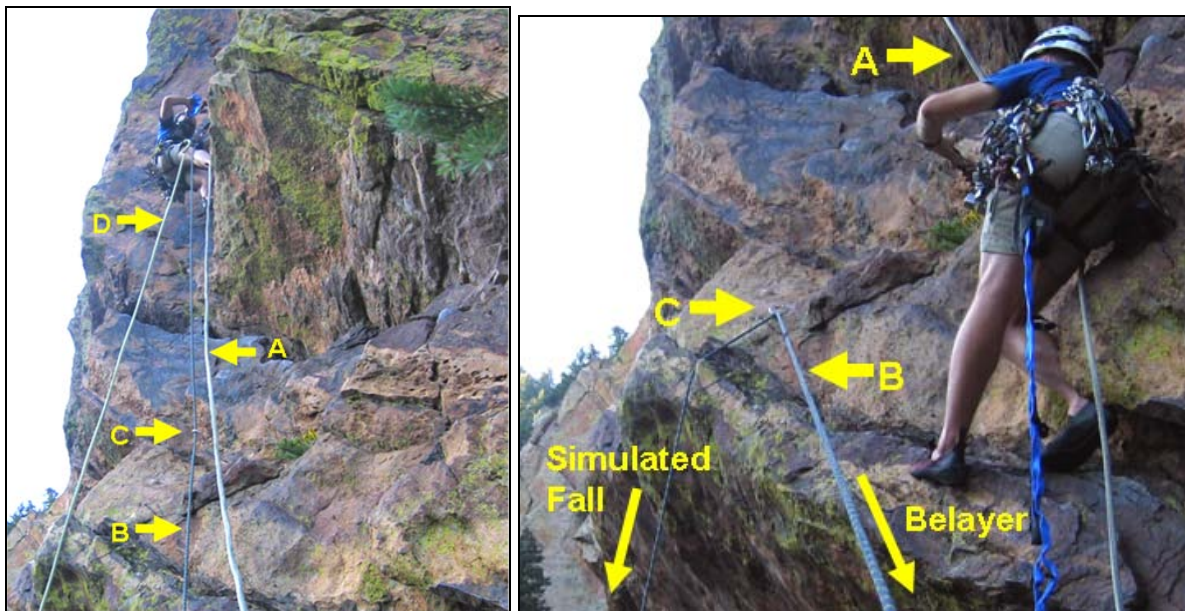
Figure 12. Re-creation configuration on Yellow Spur; a) just prior to dropping the rope & b) just after dropping the rope.

During the interview of the belayer, it was indicated that Miller fell straight down from approximately the investigators location (Figure 12a). In this re-creation, the investigator in the image dropped the simulated climber's rope straight down without adding any outward or sideways component. While the amount of force resulting from this simulated fall is much lower than what would have occurred during the actual fall, the configuration was sufficient for estimating the general rope movement characteristics during the incident.

Figure 12b shows the resulting configuration of the simulated climber's rope after being dropped from the position indicated in Figure 12a. In the image, (A) is the investigator's access rope, (B) is the climber's rope, and (C) is the carabiner. The fall line of the drop was about 2 or 3 feet (1 meter) climber's left (into the image) from the resting location of the rope. The rope dropped straight down and then pendulumed climber's right (toward the belayer) along the edge below the carabiner, finally ending up in the notch as shown in the image. The rope between the belayer and the carabiner did not contact any rock surface and there was no obvious place along that line where the rope could have snagged. The climber's side of the rope hung in free space below the overhang at the bottom of Figure 12b. There are no other obvious edges near the carabiner other than the main edge over which the rope is draped. While there are certainly other possible rope movements that could have occurred during the actual fall, this sequence and resulting position are consistent with the available information.

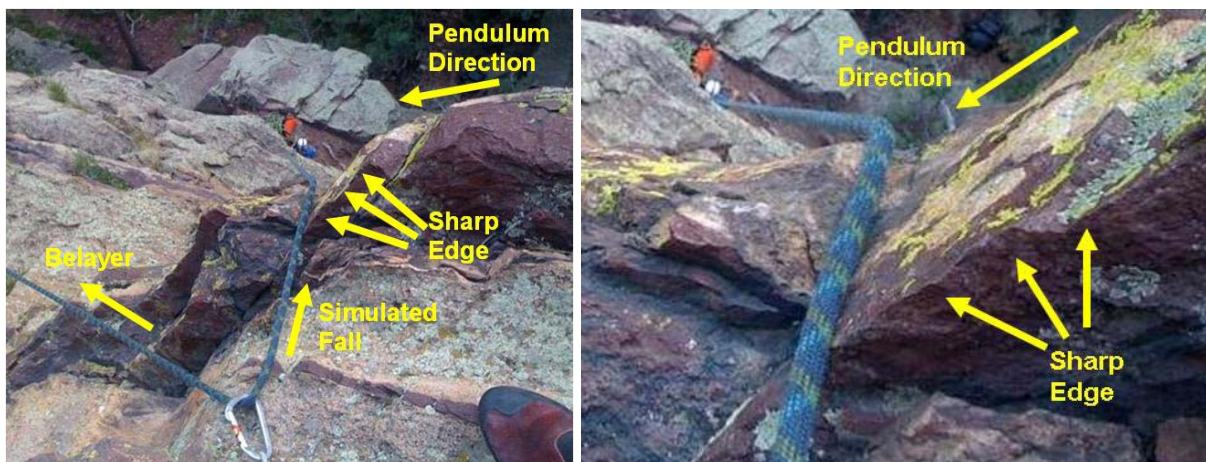
Figure 13a shows the final configuration from just above the location of the #0.4 Camalot. The climber's rope pendulumed left and down along the edge to its final resting point in the notch. The location of the carabiner is consistent with the photos taken immediately after the accident. Figure 13b shows a closer image of the edge that the rope slid over before coming to rest in the notch. The notch itself is sharp and the edge just to the right of the notch along the line the rope traveled is extremely sharp.

Figure 13. Re-creation on Yellow Spur. a) Looking down at the final configuration after simulated fall, b) Close up of the edge.

applied to the rope as it came taut over the rounded edge to the right in Figure 13a. It could then have pendulomed down along the edge toward the notch and across the very sharp edge shown in Figure 13b.

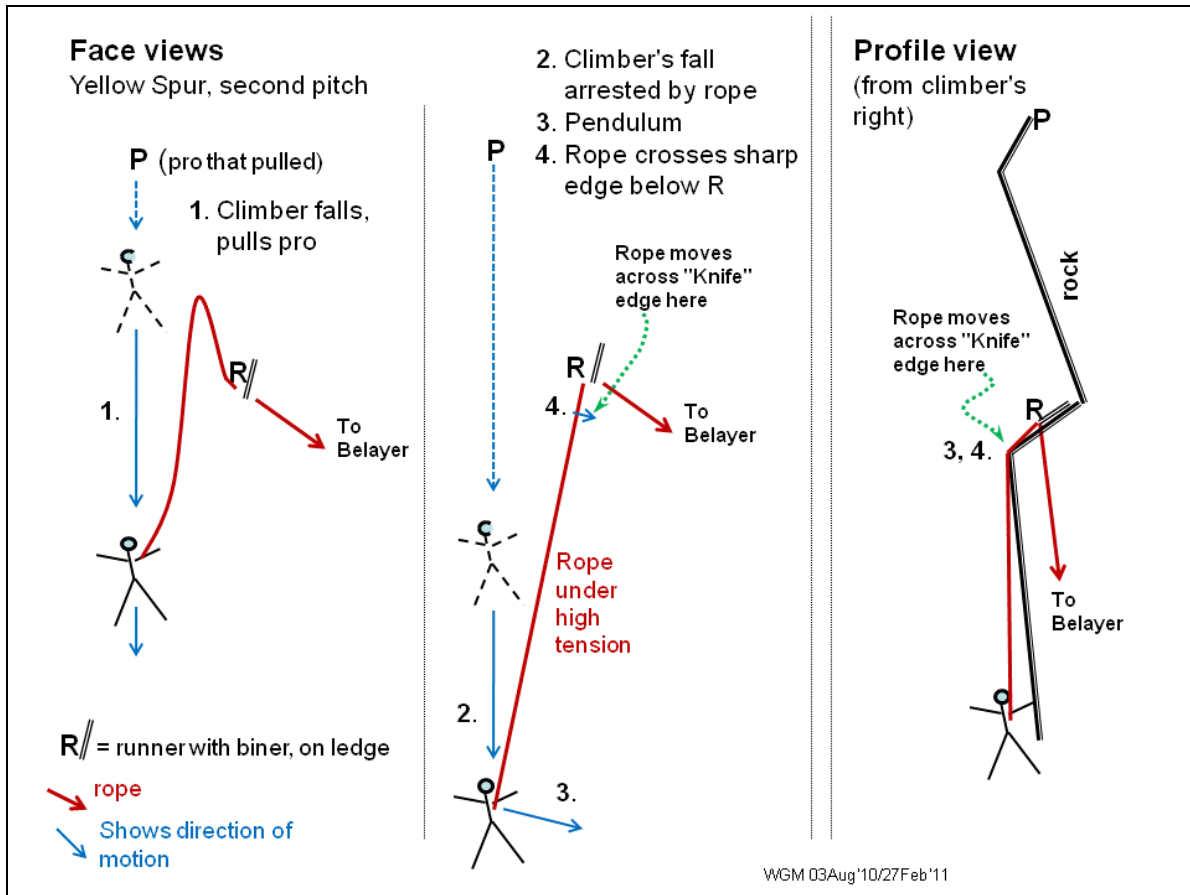
While the exact alignment of the climber and the protection he placed cannot be determined with certainty, the best estimates suggest that the fall line from the climber's high point was a few feet climber's left of the #0.4 Camalot that initially held the fall. This geometry would have resulted in the climber falling straight down until the rope between the climber and the #0.4 Camalot began to stretch. The left hand pane of Figure 14 depicts the fall relative to this piece of protection (labeled 'R'). At this point in the sequence, shown in the middle pane of Figure 14, a pendulum effect would have begun, swinging the climber to his right. The rope would therefore have moved laterally across any rock edge between the climber and the #0.4 Camalot. The right hand pane depicts the potential configuration prior to rope failure from the side⁷. Re-creation of the accident events on the route itself demonstrated that such a sequence was possible and that the rope would have pendulomed across a sharp edge. It is therefore likely that Miller's rope failed under such circumstances.

Figure 14. Potential accident sequence. Left and center pane depict sequence facing the route. Right pane depicts fall position prior to rope failure from the side.

Lead climbers often place protection after passing a ledge in order to help prevent hitting the ledge during a fall. Protection may also be placed in order to prevent falling past the ledge, especially if such a fall would result in the rope running over a sharp edge. Clearly, any ledge with a sharp edge that a leader might fall past represents an extremely high risk factor. However, the rope failure tests done during this investigation suggest two additional factors to consider during such ledge transitions. First, lead climbers should attempt to visualize the geometry of a potential fall past a ledge, and consider whether a potential pendulum effect may result in a tensioned rope moving laterally across the edge. Second, climbers should consider how that geometry could differ given the failure of any piece(s) of protection along the route, possibly leading to the rope coming in contact with nearby sharp edges that may not be directly in line with the initial fall. In some cases, hazardous situations might best be managed by altering the route in order to avoid the area or even by backing off the route.
