Rescue of an injured climber from the Redguard Route in Eldorado Canyon State Park

Events Leading to the Accident

The Rescue

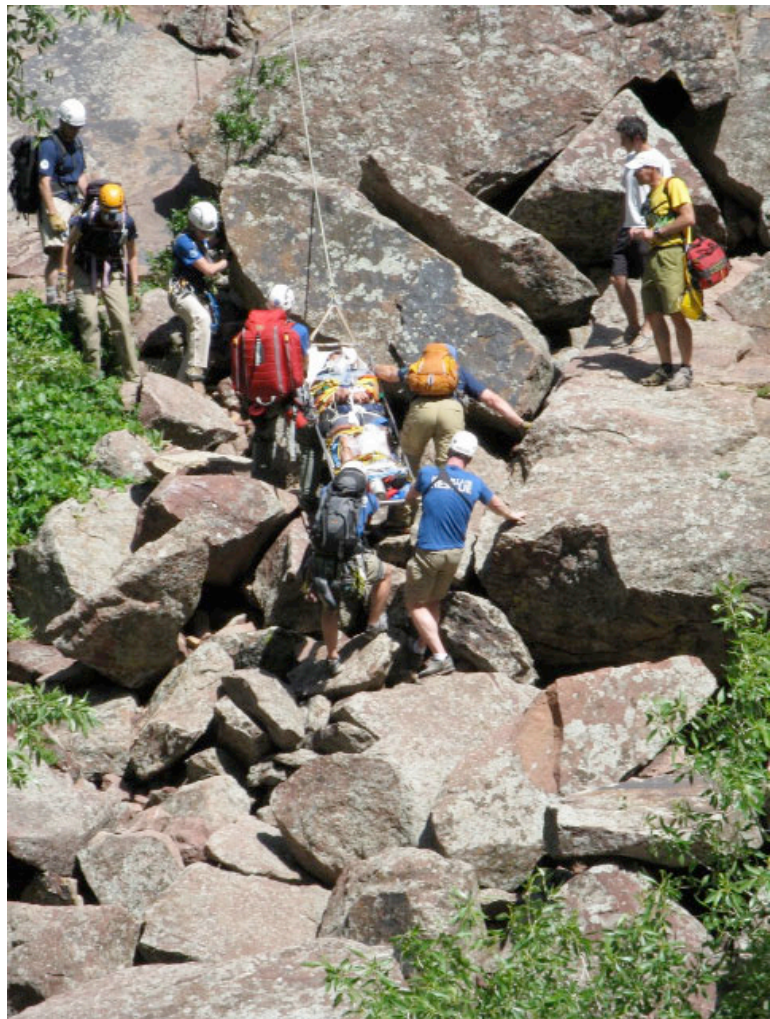
The extensive climbers' account referenced above provides significant information on the events leading up to the accident. One clear lesson can be drawn immediately: From the extent of damage to the injured climber's helmet, there is little doubt that its use prevented more significant injuries. Also, proper help from fellow climbers on scene in the early stages of an accident can prove invaluable to the effectiveness of a subsequent rescue. The climbers on the nearby route that lowered and fixed their climbing ropes for ascent by RMRG members increased the speed of getting advanced medical personnel to the injured climber. Additionally, the added risks of the simul-climbing technique must be fully understood before it is employed. In this case the climbers had an
