Yellow Spur Rope Failure Investigation by **Rocky Mountain Rescue Group**

March 6, 2011

On the morning of June 22, 2010, Joseph Miller fell while leading the second pitch of the Yellow Spur¹ route on the Redgarden Wall in Eldorado Canyon State Park². During the fall the climber's rope failed, resulting in a fatal ground fall.

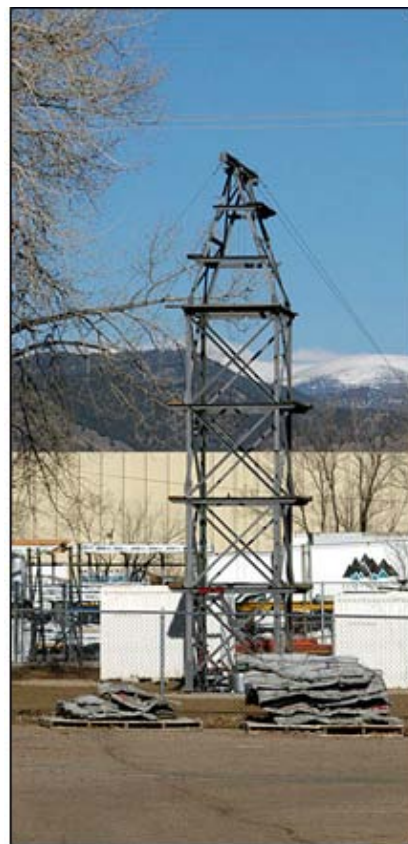
Figure 4. The RMRG test facility

The majority of the testing presented in this paper was conducted on RMRG's 35-foot (10.7 m) tall steel test tower⁴ (Figure 4). The tower is outfitted with a mechanical hoist and a stack of thirty 33-pound (15 kg) steel plates (for a total of 1000 pounds (455 kg)), which can be used to create a wide range of test loads. Drops are initiated using a pneumatic release mechanism (McMillan Design's "Sea Catch") and can be triggered either manually or via computer. Data is collected by a laptop computer with a National Instruments data acquisition card (Model 6251) and LabView 8.2 software. A variety of sensors collect load, temperature, and distance measurements. The load sensors have an operational range of up to 10,000 pounds (44.5 kN) and the data acquisition system allows sampling rates greater than 2500 samples per second. The
